## Safe Use of Quick Hitches on Excavators

# Important Safety Alert

# Always check that your Safety Pin is engaged !

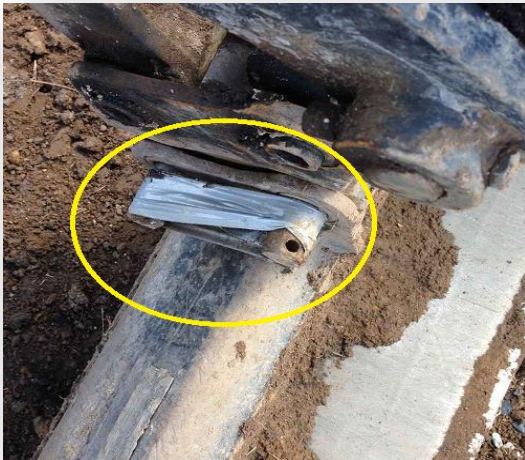
Today, a contractor at Woongarra, was found to be holding the safety pin in place with duct tape (*their reason, it keeps falling out*). Work was stopped and they cannot recommence until the Safety Pin is utilised correctly.

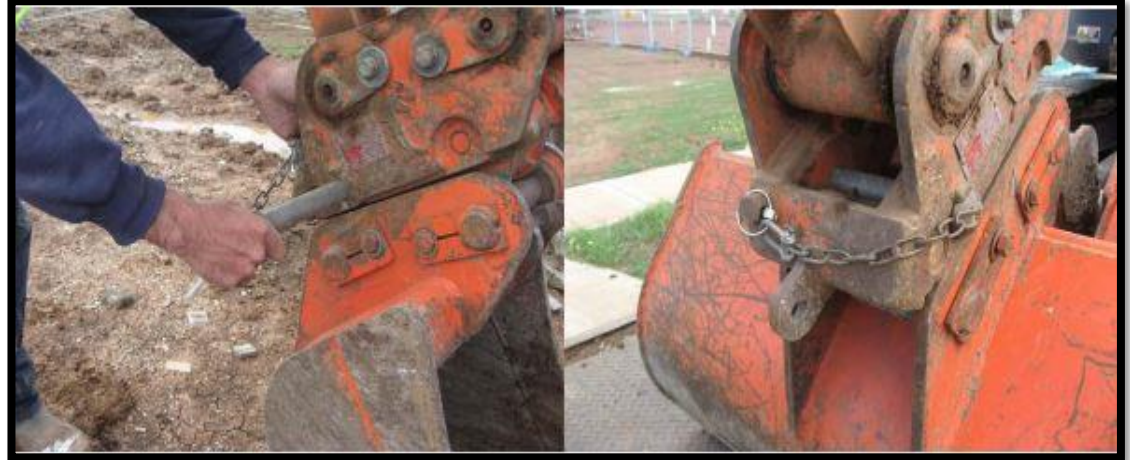
Quick Hitch Safety Pin being inserted

Quick Hitch Safety Pin in place with Lynch Pins and Chain

As such, all Hudson Homes Supervisor are now required to regularly inspect their trades (contractors) excavators and backhoes (which utilise quick hitches) to ensure that safety pins are being used and held in place correctly.

*Plant used on any Hudson Homes site that utilise quick hitch attachments and that are found to be operating without a safety pin installed or engaged properly will be immediately removed from site.*

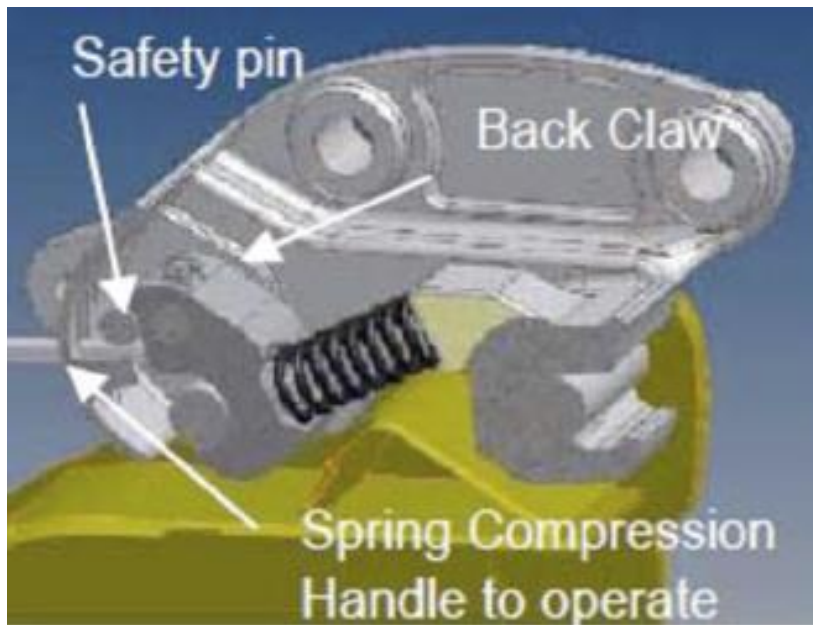
Figure 1 – Spring latch mechanism

# Manual Quick Hitches

With a manual and semi-automatic quick hitch, in order to use the quick hitch safety pin correctly, the operator needs to exit the cab once to remove the pin, then again to install it in the new attachment once fitted. Complacency sets in, blokes get lazy and suddenly you've got a qualified and experienced operator taking a deadly gamble with his workmates very existence.

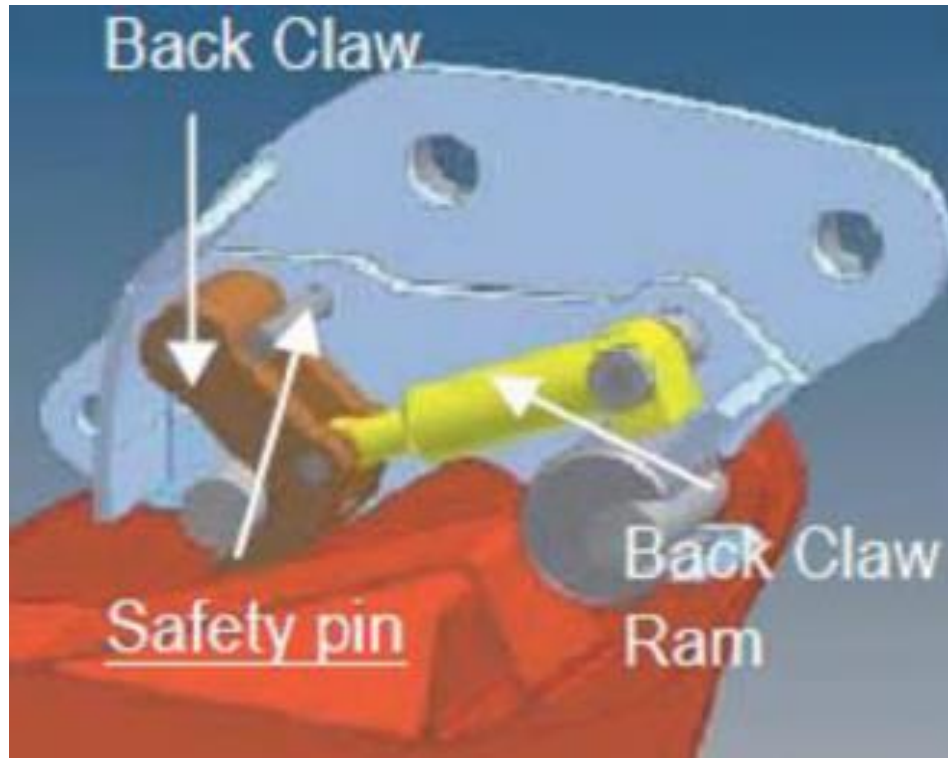
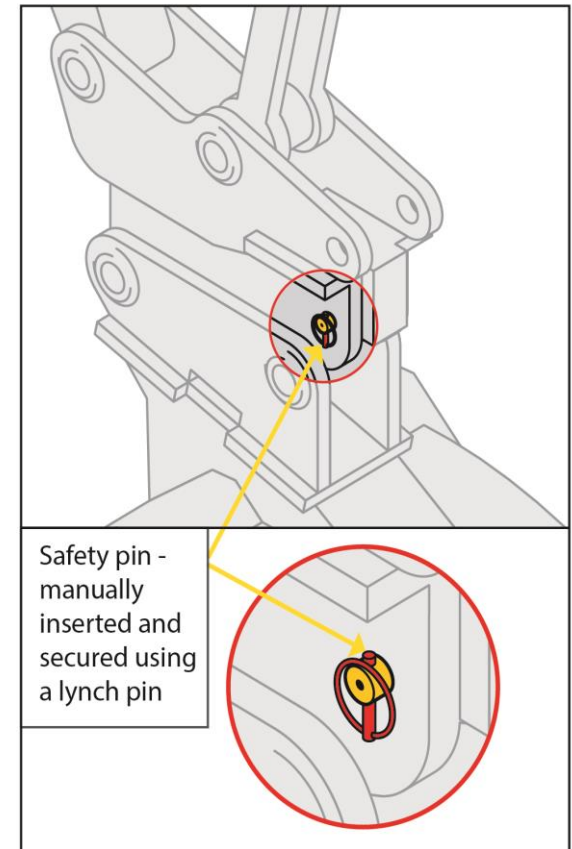
Figure 3 – Semi-automatic quick hitch

# Semi Automatic Quick Hitches

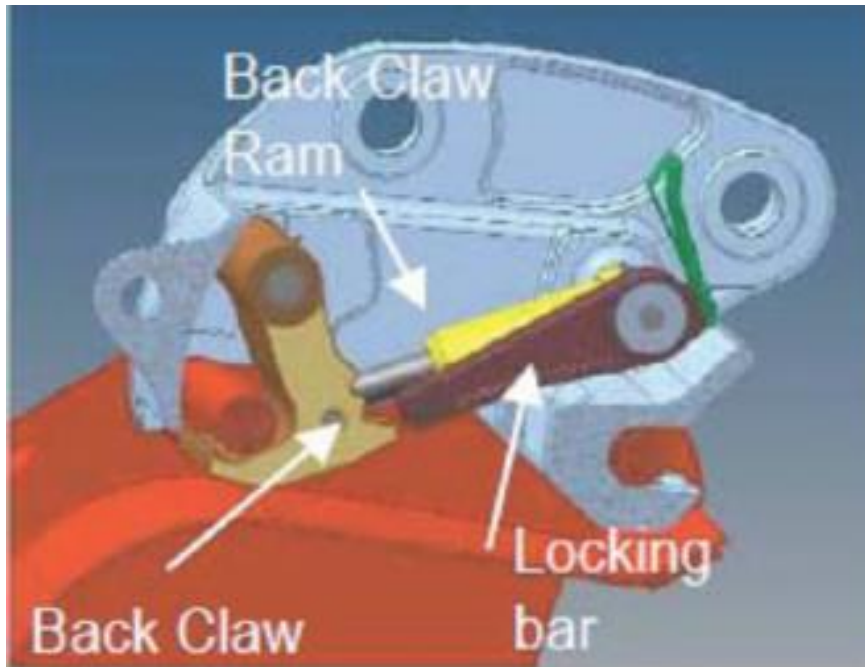
Figure 4 – Single claw lock type

# Fully Automatic Quick Hitches

Operator can see the Safety Pin engaged from the Cabin !
